ASBESTOS SURVEY AND ASSESSMENT REPORT

DPW PROJECT #89-773

IDAHO STATE TRANSPORTATION DEPARTMENT
DISTRICTS 04, 05 AND 06 DIVISION OF HIGHWAYS
SHOSHONE, POCA TELLO AND RIGBY, IDAHO

JULY 1989

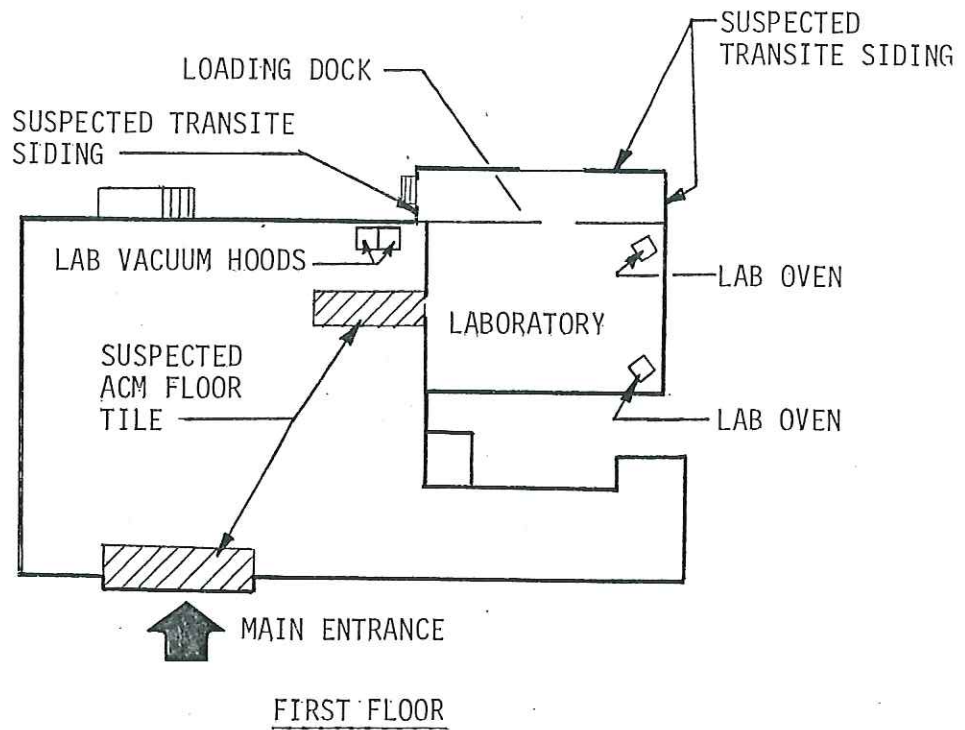
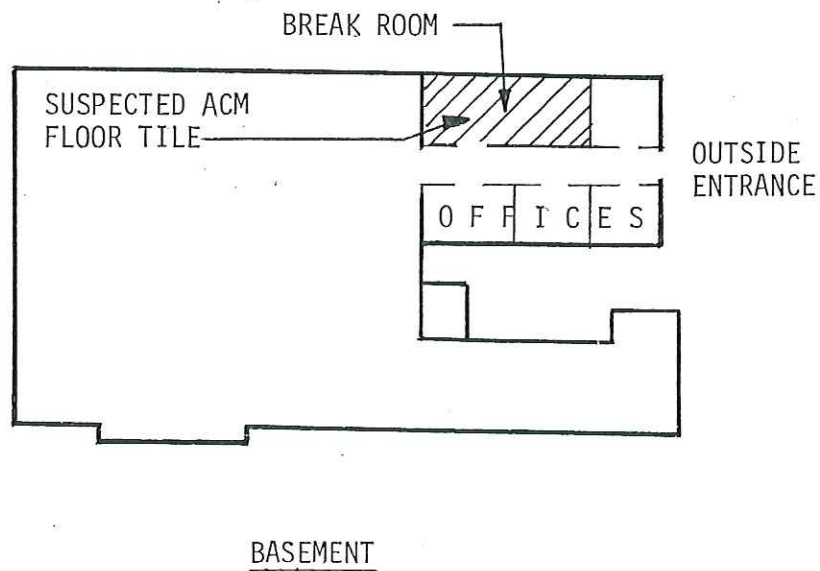
DRAWING NO. 2
ADMINISTRATION BUILDING
NUMBER 4251
SHOSHONE, IDAHO

The Shoshone Administration Building is a single story brick, concrete block and wood frame structure with a subgrade basement and asphalt roof (see Ref. Dwg. Nos. 1 & 2 and Ref. Photograph Nos. 1 & 2). The Administration Building has undergone several remodeling projects and additions with an extensive abatement of the asbestos thermal systems pipe insulation throughout the building. MK scope of work included the materials found in the laboratory and the adjacent loading dock located on the northwest side of the building (see Ref. Photograph No. 2). MK consultants were directed by DPW representatives that the building was considered asbestos-free and no destructive sampling was to be performed. This, along with the recent remodel, accounts for the assumed list of materials in the table below and the absence of bulk material sample analyses for the materials suspected of containing asbestos. MK recommends that the lab oven door gaskets and insulated lab gloves quantified in the table below be remediated as soon as possible.

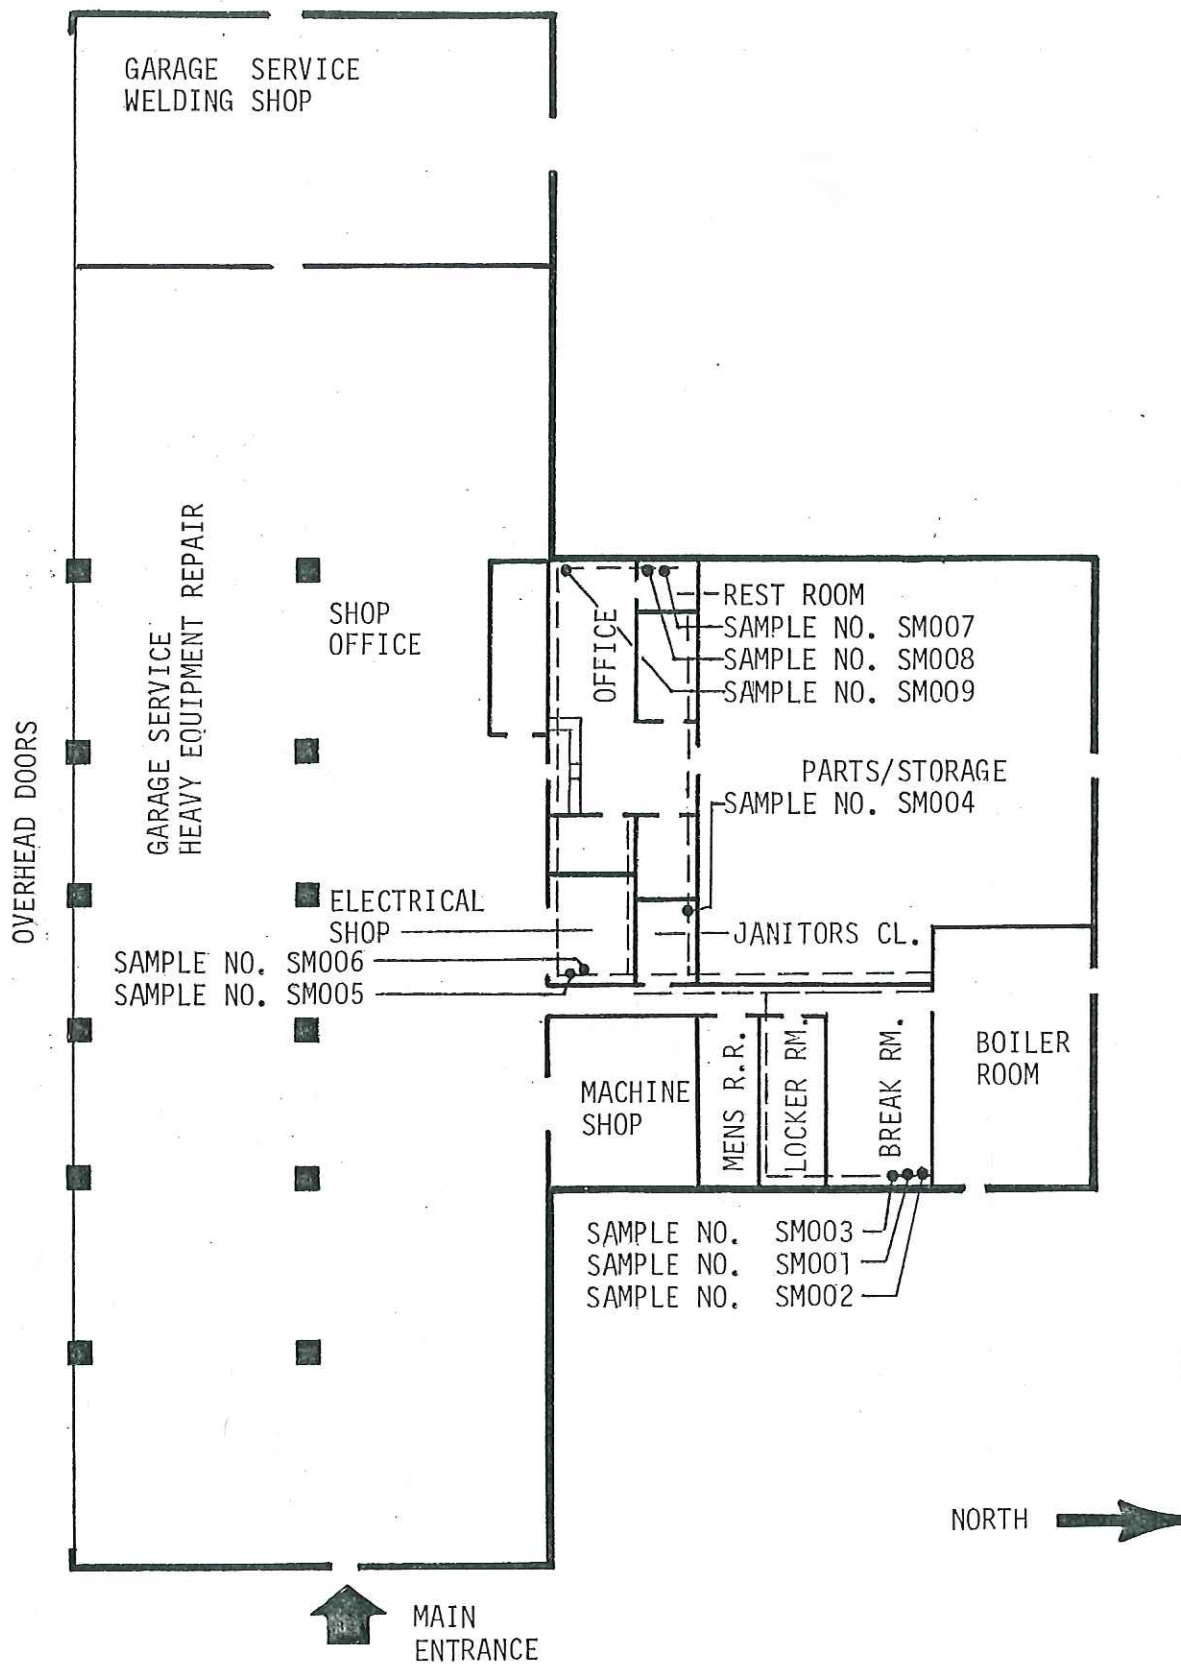
DRAWING NO. 3
SERVICE MAINTENANCE
SHOP BUILDING
NUMBER 4252
SHOSHONE, IDAHO

The Shoshone Maintenance Shop Building is a concrete block and wood frame structure with asphalt roof and concrete slab floor (see Ref. Dwg. Nos. 1 & 3 and Ref. Photograph No. 6). The building houses work bays, parts/supply storeroom, offices, employee break room, restrooms, and machinist shop.

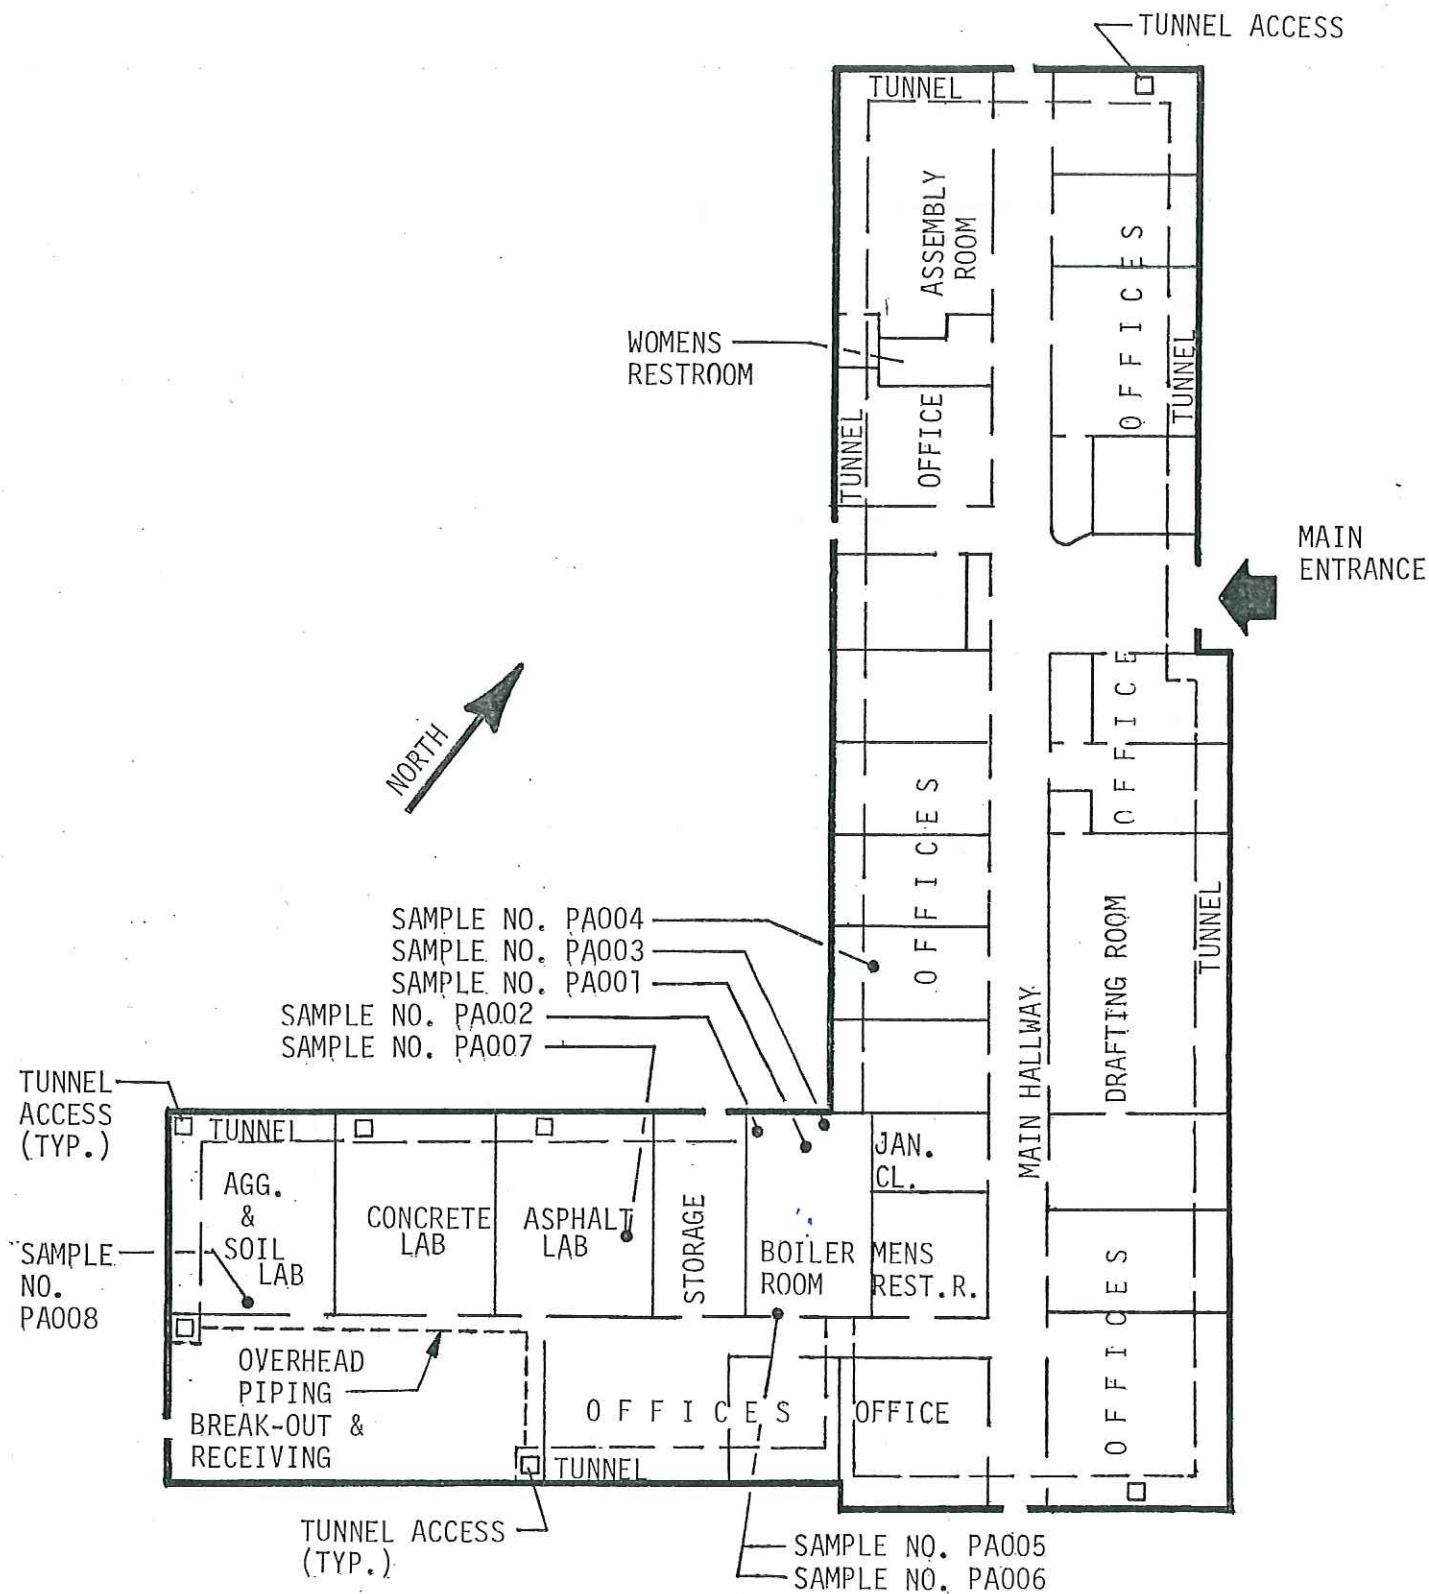
DRAWING NO. 5
 ADMINISTRATION BUILDING
 NUMBER 1401
 POCA TELLO, IDAHO

District 05 Pocatello Administration Building is a concrete block and brick frame structure with asphalt built-up roof, concrete floor, and a concrete mechanical tunnel which encircles the perimeter of the building (see Ref. Dwg. Nos. 4 & 5 and Ref. Photograph Nos. 11 & 12). The building houses administration and design engineering offices and engineering labs. MK recommends that the lab oven door gaskets and insulated lab gloves quantified in the table below be remediated as soon as possible.

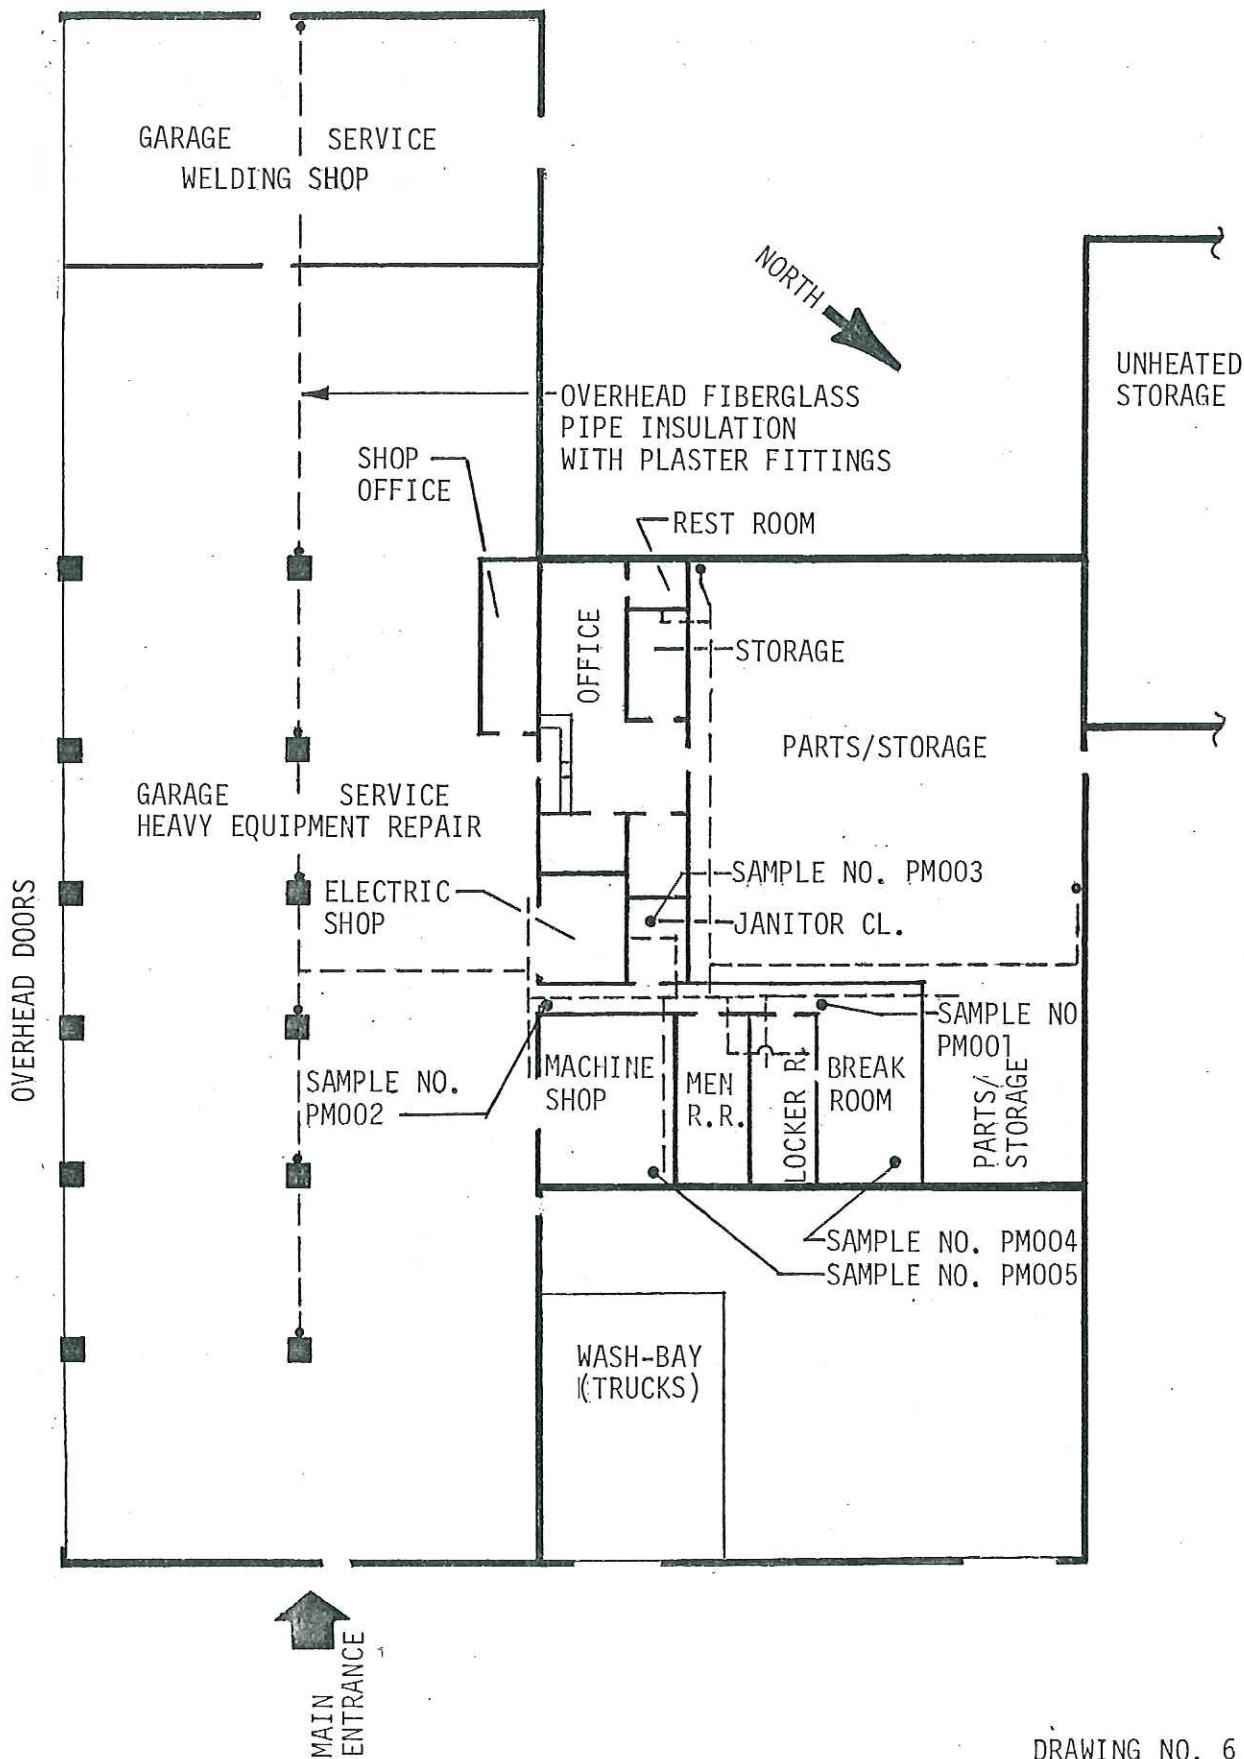
DRAWING NO. 6
SERVICE MAINTENANCE
SHOP BUILDING
NUMBER 1402
POCATELLO, IDAHO

The District 05 Maintenance Shop is a concrete block frame structure with concrete floor and precast concrete T-beam ceiling with asphalt roof (see Ref. Dwg. Nos. 4 & 6 and Ref. Photograph No. 16). The building houses work bays, parts/supply storeroom, offices, employees break room, restrooms, and machinist shop. MK recommends that the 3' x 5' board quantified in the table below be remediated as soon as possible.

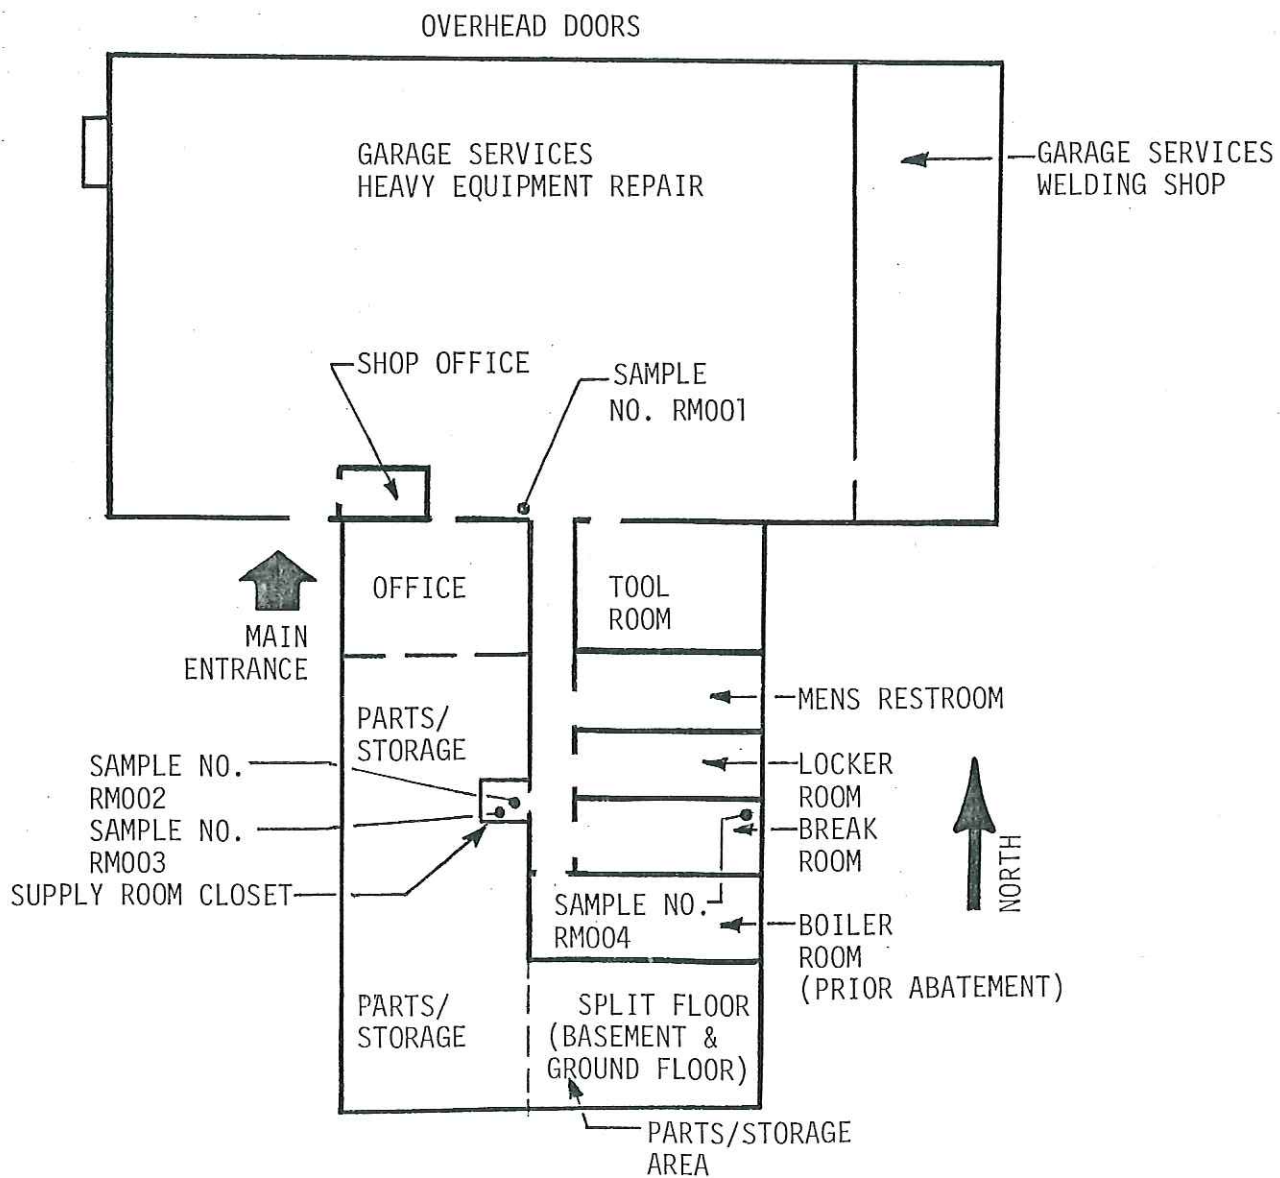
DRAWING NO. 10
SERVICE MAINTENANCE SHOP
BUILDING NO. 6093
RIGBY, IDAHO

The District 06 Maintenance Shop is a concrete block and wood frame structure with concrete floor and precast concrete T-beam ceiling with asphalt roof (see Ref. Dwg. Nos. 7 & 10 and Ref. Photograph No. 30). The building houses service work bays, parts/supply storeroom, offices, employees break room, locker/restrooms, and machinist shop. The Boiler Room has undergone an extensive abatement of the asbestos thermal systems pipe insulation. The

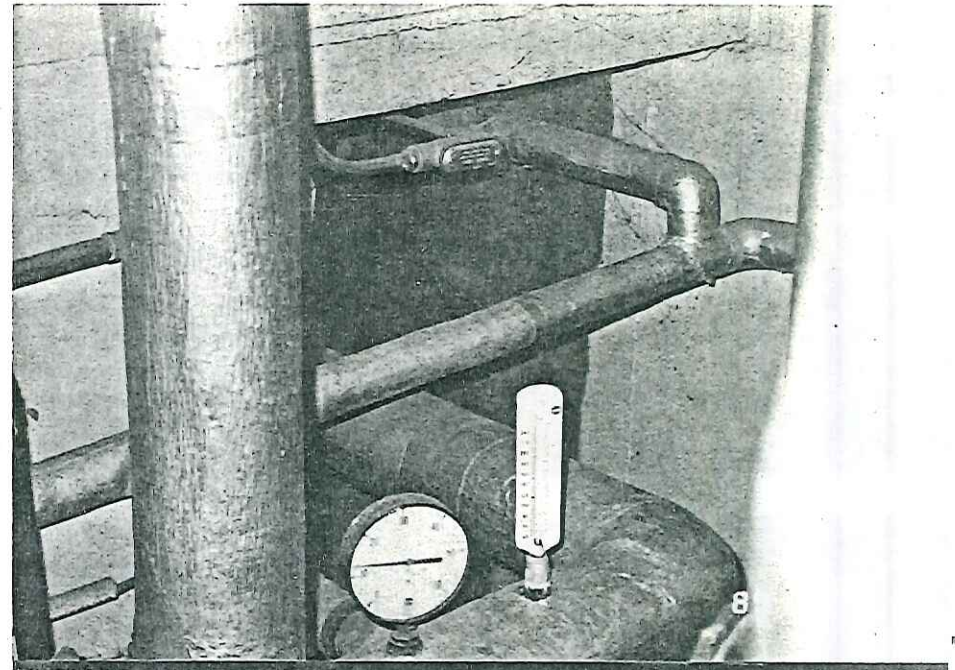
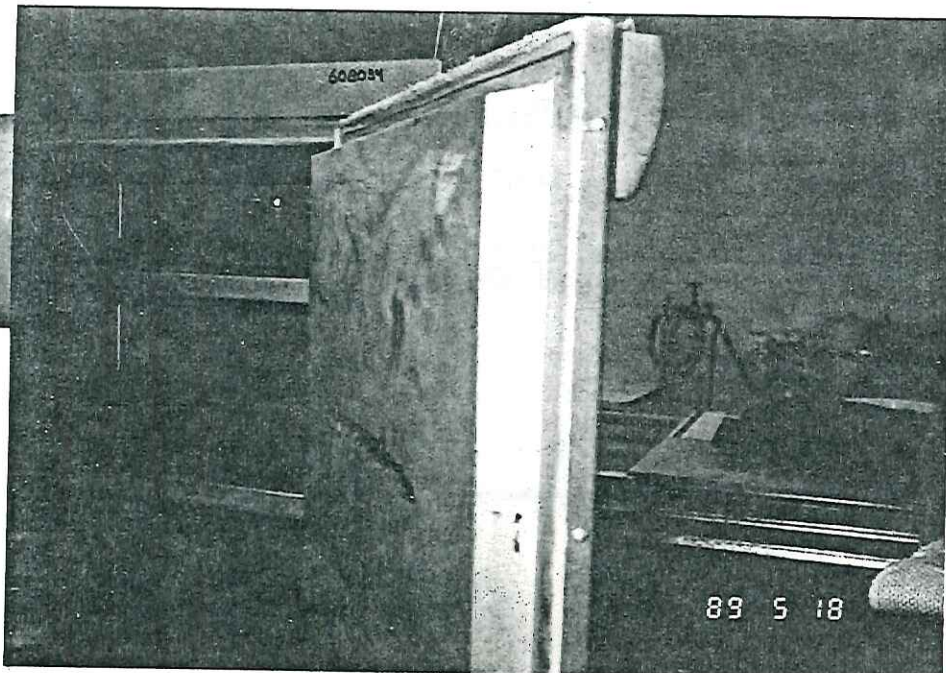
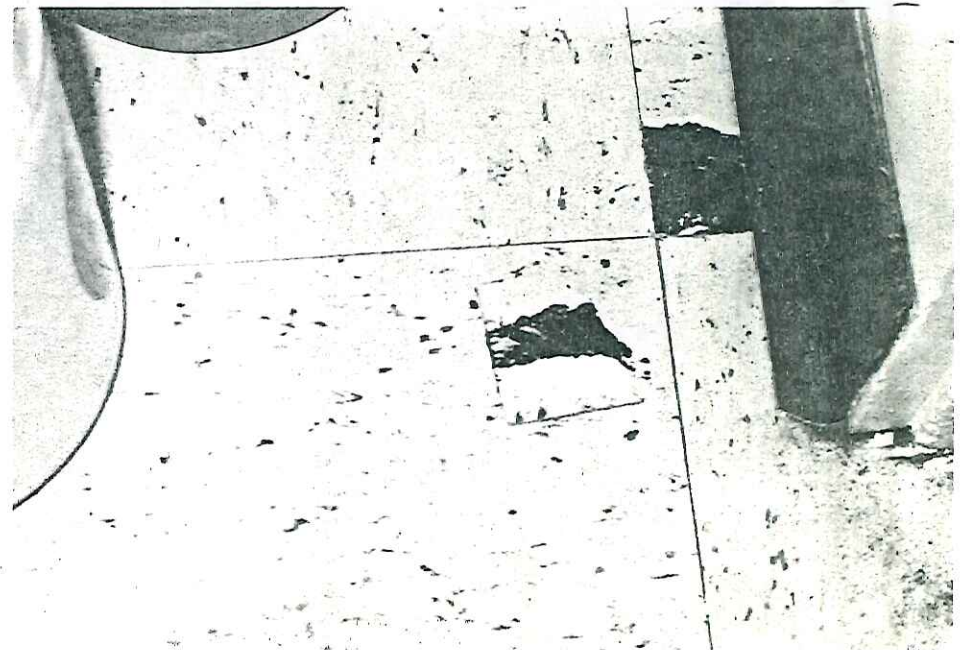
14 Hallway - 9" Floor Tile and Mastic (PA010)

15 Laboratory - Lab Oven and Lab Oven Door Gasket
(PA007)

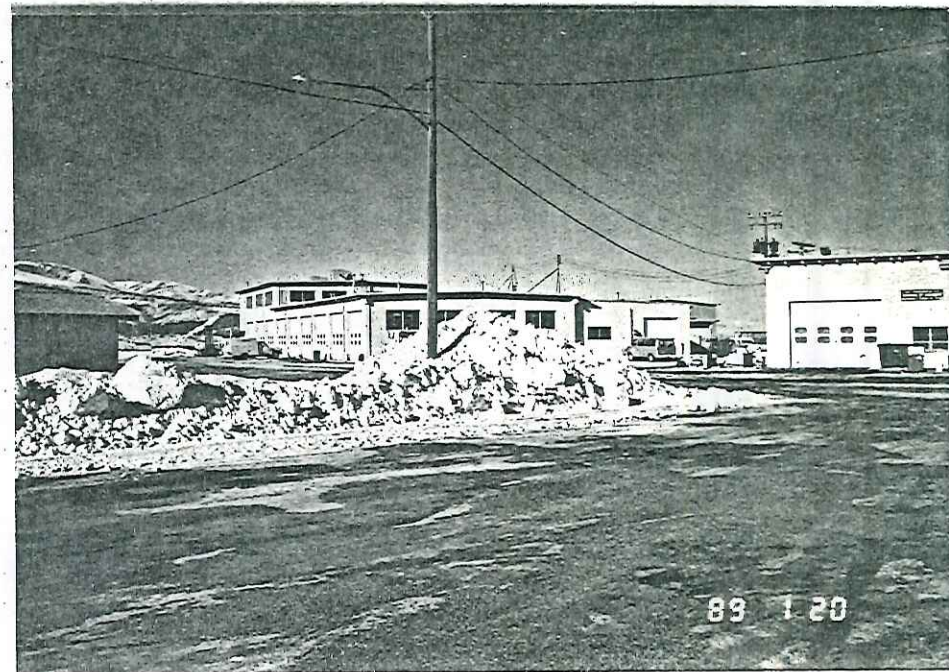
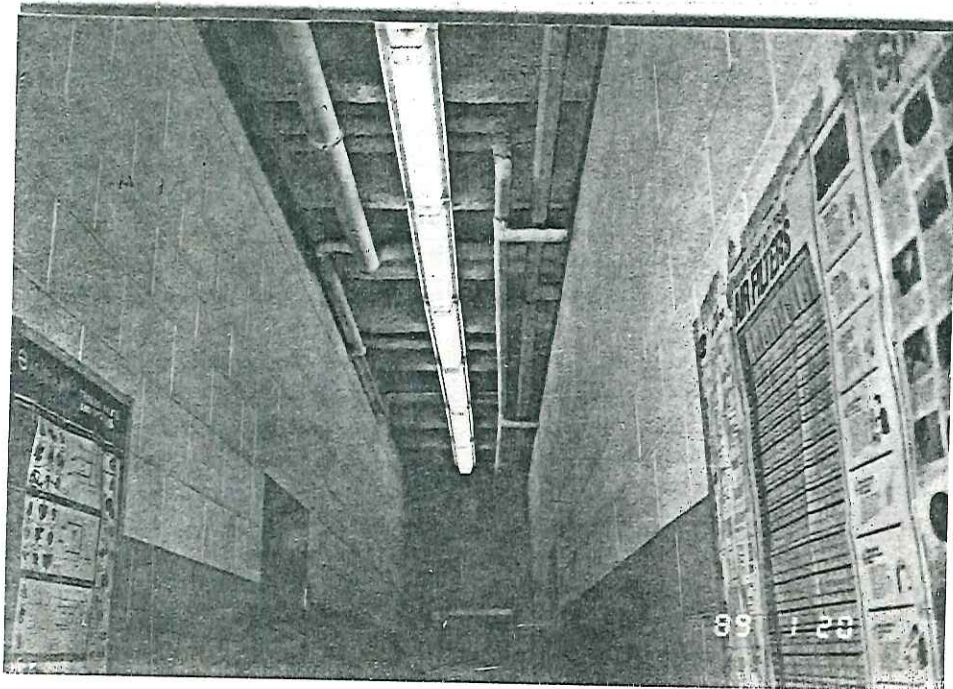
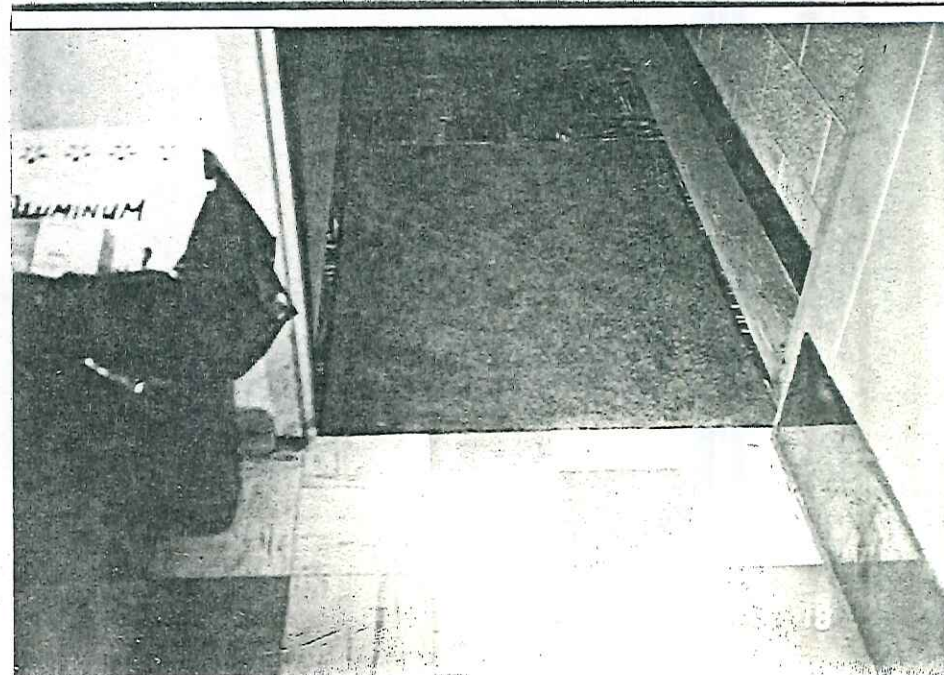
17 Break Room and Hallway - 9" Floor Tile and
Mastic (PM001A)

18 Sprayed-on Ceiling in Hallway. Obvious over-
spray on TSI. Typical of Sprayed-on Ceiling.

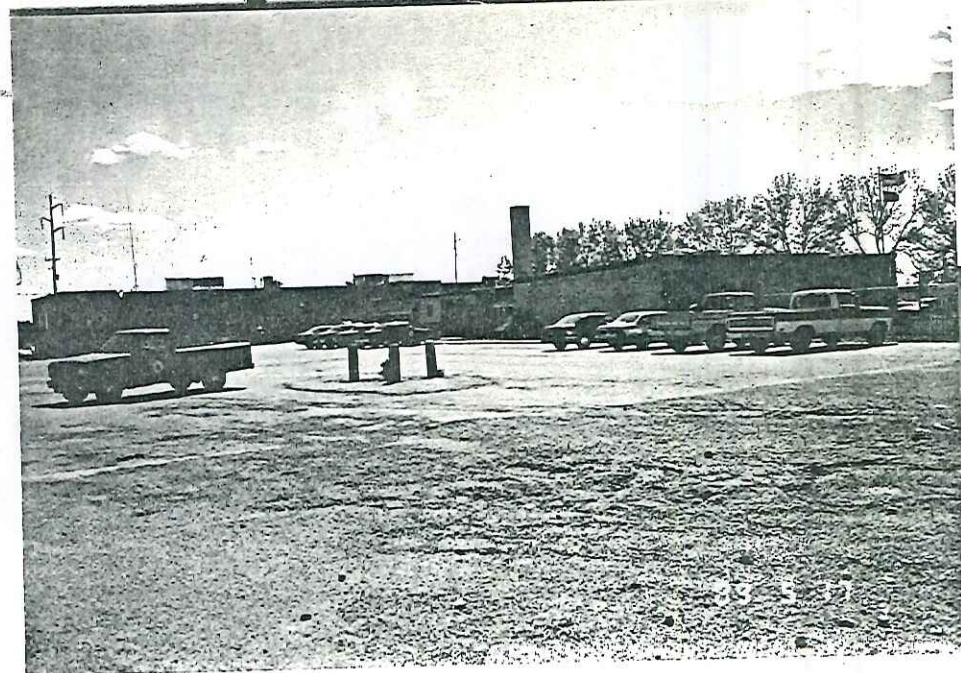
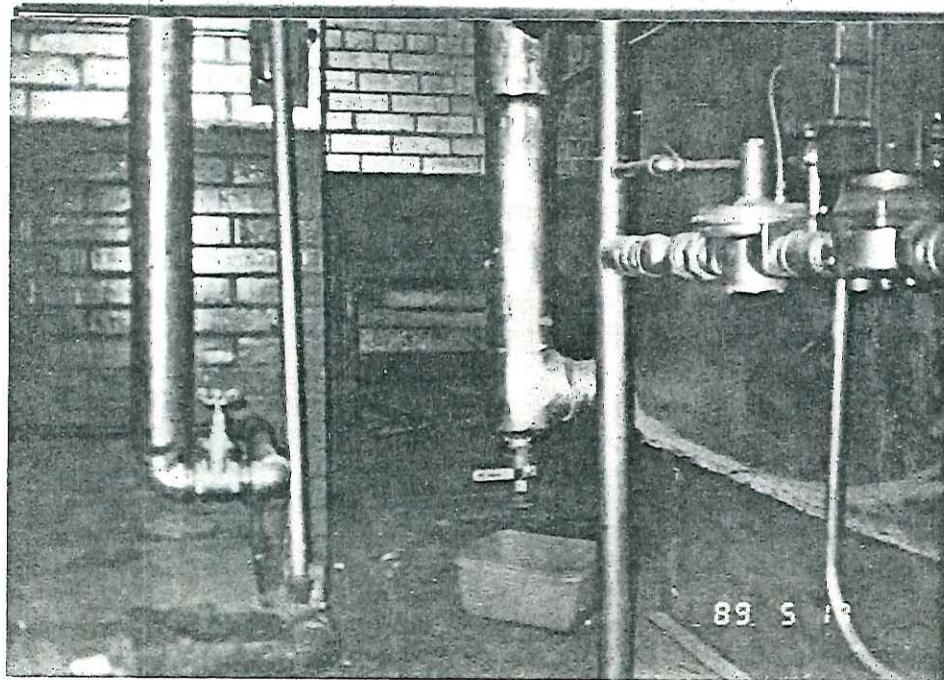
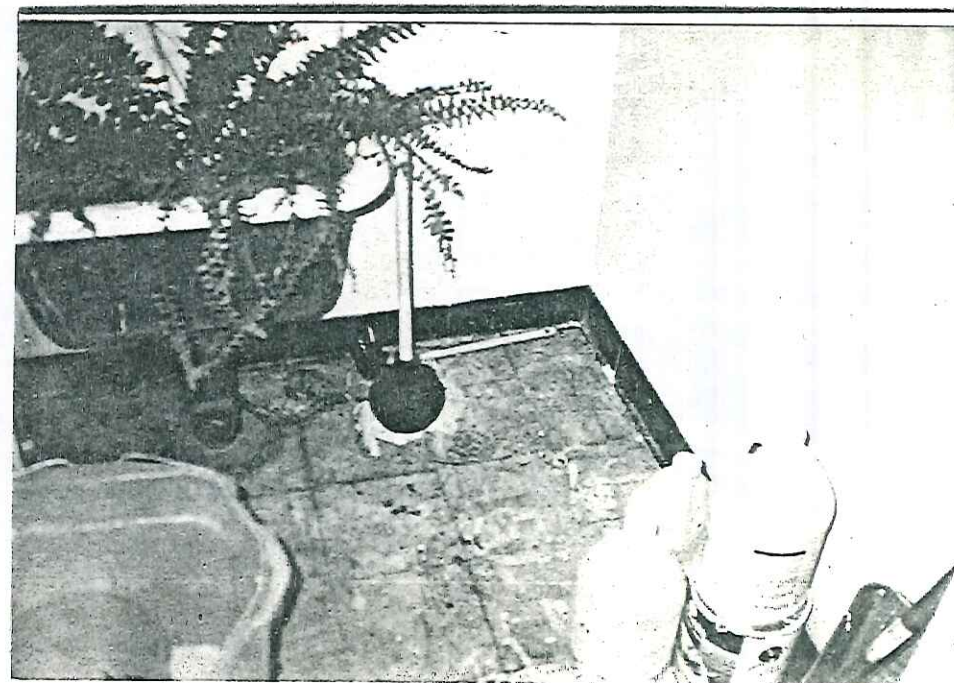
- 22 Northeast view of building - Original building
on right side of photo
- 23 Janitors closet - 9" floor Tile and Mastic
(RA005)
- 24 Boiler Room - Crawlspace Access, visible
construction debris

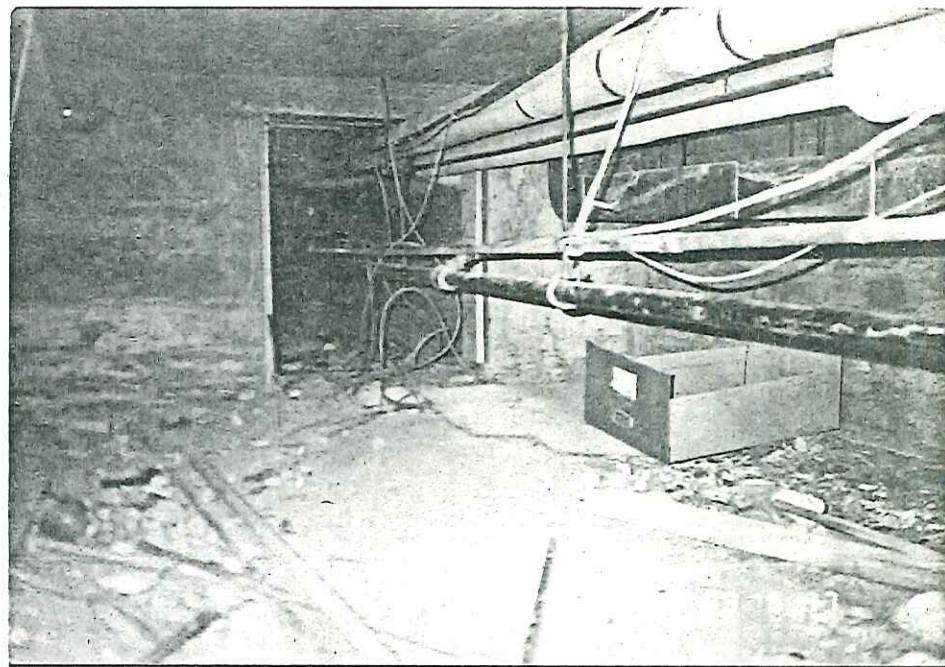
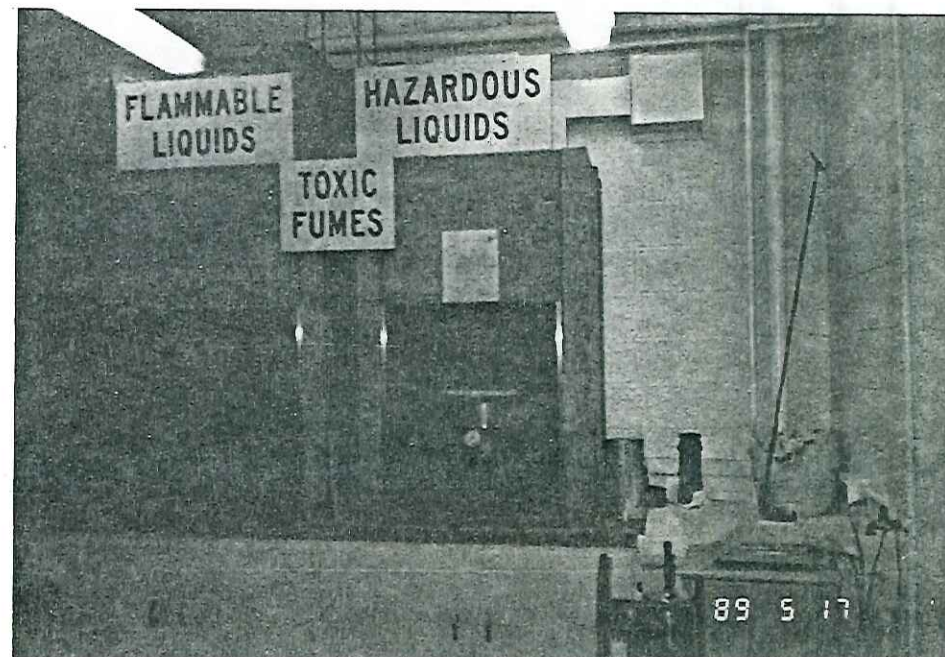
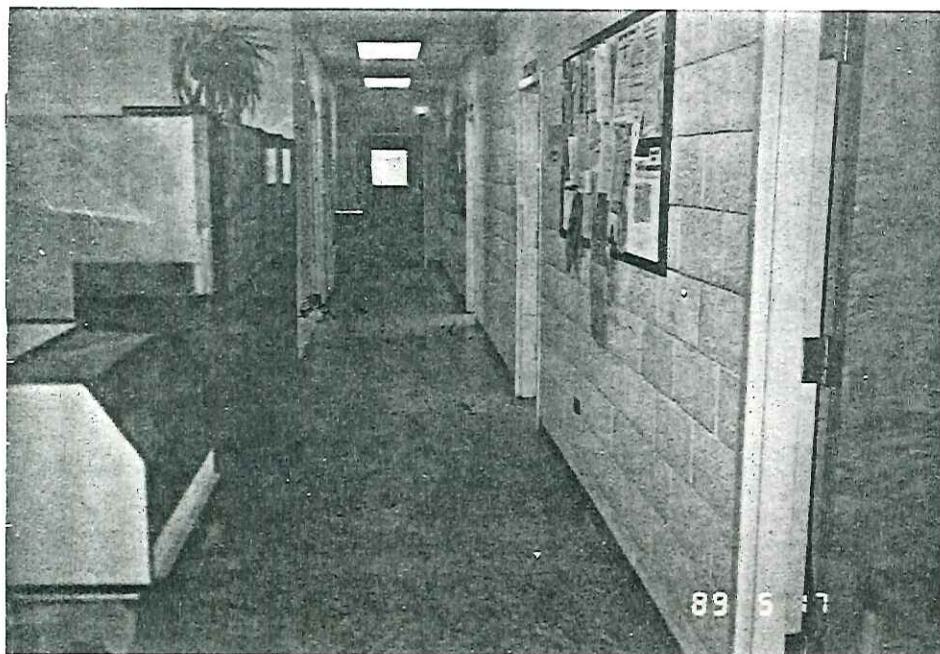
<u>Description</u>	<u>Quantity</u>	<u>Area</u>	<u>Refer. Sample</u>	<u>Asbestos Content</u>	<u>Response Action</u>	<u>Refer. Photo</u>	<u>Ref. Floor Plans</u>
9" floor tile (under carpet)	4,961 SF	A	9773RA005A	12% CH	3, GR	Sim. 27	8
Floor tile mastic	2,370 SF	A,C D	9773RA006, 9773RA007, 9773RA008	3-5% CH, 3-5% CH, 5% CH	3, GR	Sim. 27	8,9
Plaster fitting	285 EA	B	9773RA009	5% CH <1% AM	2, GB	24	9
Ground contam. (1" to 2" depth)	3,510 SF	B	9773RA010	5% CH, 1% AM	1, G	25	8
Lab vacuum hood	176 SF	A	NS	Assumed	3, OM	26	8

- 25 Crawlspace - Construction Debris and ACM
Ground Contamination (RA010)
- 26 Laboratory - Vacuum Hoods (Transite)
- 27 Hallway, New Addition - 12" Floor Tile and
Mastic (RA007)
